## IMPROVED ST WIPER RING DESIGN

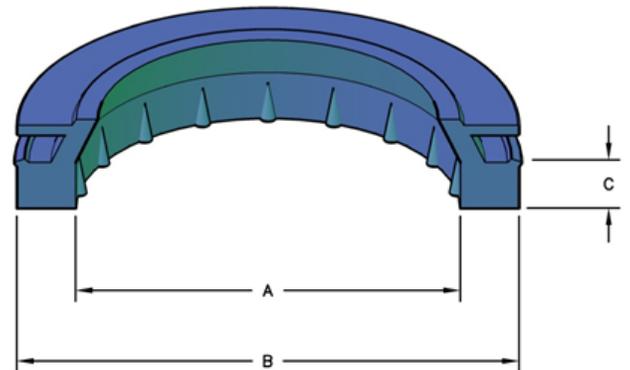
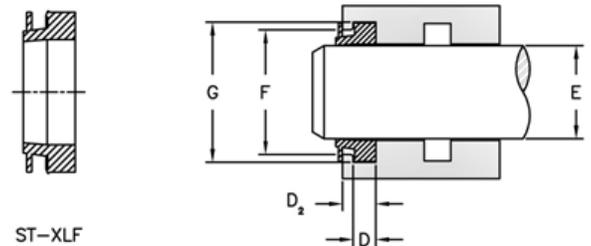
Some cylinder manufactures are already utilizing this new design of ST / D wiper ring. However, the problem with this design in repair work is that the gland must be designed / machined to fit the dimension between the wiper base and the flap. If the gland was not designed for this wiper originally it may need to be “faced off” if that area of the gland is too thick. If the outer flange of the wiper is too narrow to totally fill the space on the wiper it would necessitate a new gland to be manufactured to enjoy the benefits of this wiper design.

This new “XLF” style wiper ring goes the additional step of utilizing a “dust lip” or flap molded onto the wiper lip at the outer edge of the wiper lip. This “dust lip” is designed to prevent most contaminants from building up in the area where the wiper lip joins the base and snaps into the wiper groove. Preventing the contaminant from building up in this “canyon” where the wiper lip, wiper base and gland meet keeps more contamination, especially fine dust, from working its way into the gland wiper groove and eventually beyond into the cylinder.
